Reliability Improvements for an Automotive Fuel Level Sensor

Hugh W. Ireland
Robert L. Farrar
Delphi Automotive
Flint, Michigan

An experimental program was undertaken to improve the rotational life of an automotive fuel level sensor. The potentiometric design of this sensor utilizes a Pd based contact material sliding along two thick film, conductive Ag tracks. One track was the continuous ground or return leg, and the other track was composed of discrete segments radially terminated into the resistive leg. Abrasive wear of the contact sliding against the segmented track was found to determine the useful lifetime of the sensor. Previous work had shown that reductions in the contact normal force produced unacceptable noise due to a failure to break through the gasoline generated sulfide films on the inks. This paper reviews the efforts to improve the wear characteristics of the inks. Although some wear improvements were obtained by mechanical polishing after firing, this introduced output noise caused by sulfide films. More dramatic improvements were achieved by utilizing a different ink formulation that incorporated a finer frit. With the new ink and an optimized firing schedule,

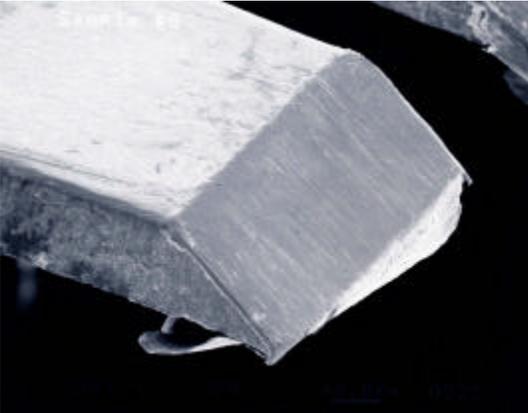
Figure 7b. Surface SEM photomicrograph of a sliding contact from a second sample after only 4.0 million cycles mated against the as fired, coarse frit ink.

In contrast, the abrasive wear, seen in figures 7b and 8, acts to keep the contact surface clean of films. Therefore, it appears that one approach to ensuring a low noise contact system is to allow mild abrasive wear to clean the contacts. With this approach, the level of wear is likely to determine the cyclic lifetime of the sensor. However, if not controlled properly, the wear can become excessive and lead to premature mechanical failure (see figure 7b).

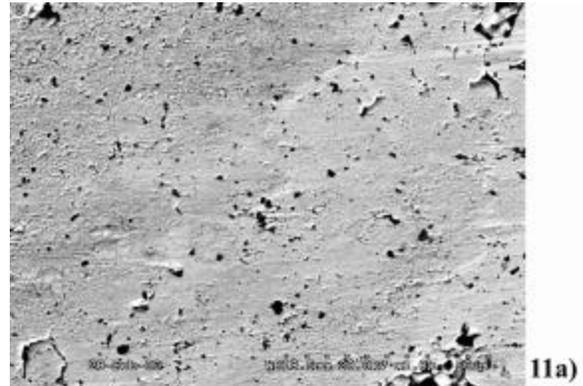
Figure 11. SEM photomicrographs of the two as fired ink surfaces after different levels of cyclic wear.
 a) Coarse frit ink after 250,000 cycles
 b and c) Fine frit ink after 1,250,000 cycles

Figure 11 contains surface SEM photomicrographs of the ink surface after different levels of wear. Figure 11 a shows a very flat, burnished appearance typical of the coarse frit ink. This sample was found on one of the segmented spokes after only 250,000 cycles on the as fired, coarse frit ink. In contrast, figure 11b and c show the surface of the fine frit ink after 1,250,000 cycles. In this case, even with five times more cyclic

motion, the surface still shows much of the original as fired topography. Additionally, the higher magnification view in figure 11c shows scratches initiating from the surface glass particles. The lack of excessive burnishing suggests the contact actually rides on the surface of the glass particles.
